New testing methodology for weight reduction

Automotive industry – Case of tensile test with DIC strain analysis of composite material

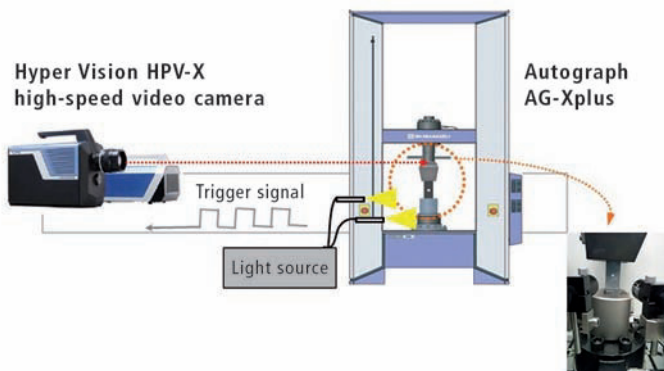
Figure 1: Main unit combined with the HPV-X2 Camera

This article explains how to use the precision universal testing machine (Autograph AG-X plus 250 kN) and the high-speed video camera (Hyper Vision HPV-X) (figure 1) to evaluate the static fracture behaviour of a CFRP based on a test force attenuation graph and images of material failure. Information on specimens is shown in table 1. A 6 mm diameter hole is machined in the specimen centre. Fractures are known to propagate easily through composite materials from the initial damage point, and when a crack or hole is present, the material strength is reduced markedly. Therefore, evaluation of the strength of open-hole specimens

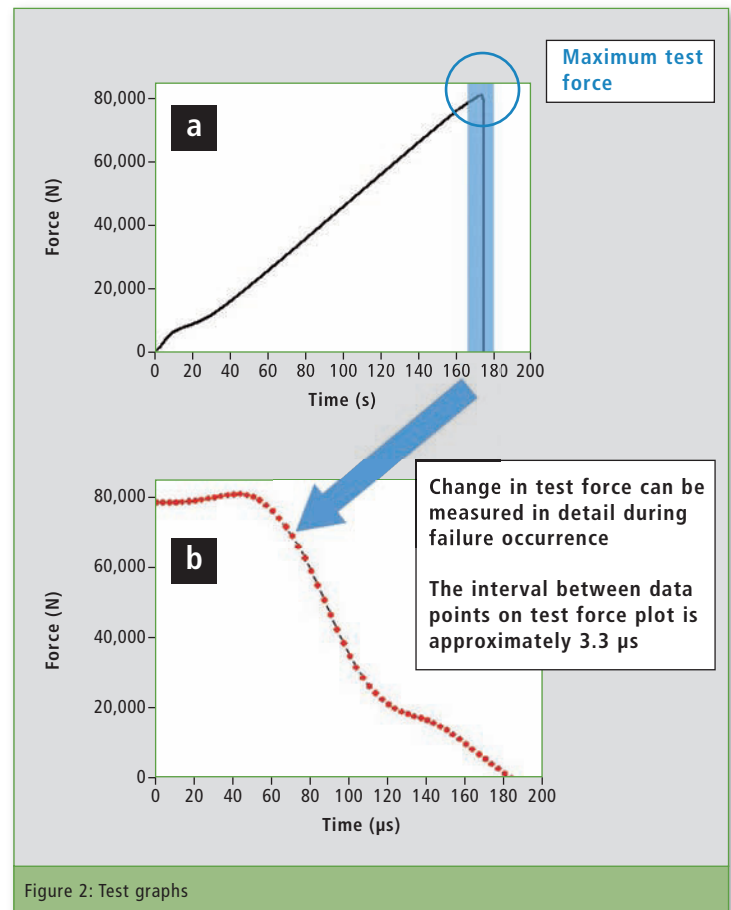
Figure 2: Test graphs

conditions shown in table 2. A test force-displacement plot for the open-hole quasi-isotropic CFRP (OH-CFRP) is shown in figure 2a. A test force-time plot during the occurrence of material fracture is also shown in figure 2b.

Figure 2a can be interpreted to show that the specimen fractured at the moment it reached maximum test force, at which point the load on the specimen was suddenly released. This testing system can be used to perform high-speed sampling to measure in detail the change in test force in the region of maximum test force. The time interval between data points on the test force plot in figure 2b is 3.3 μ s.

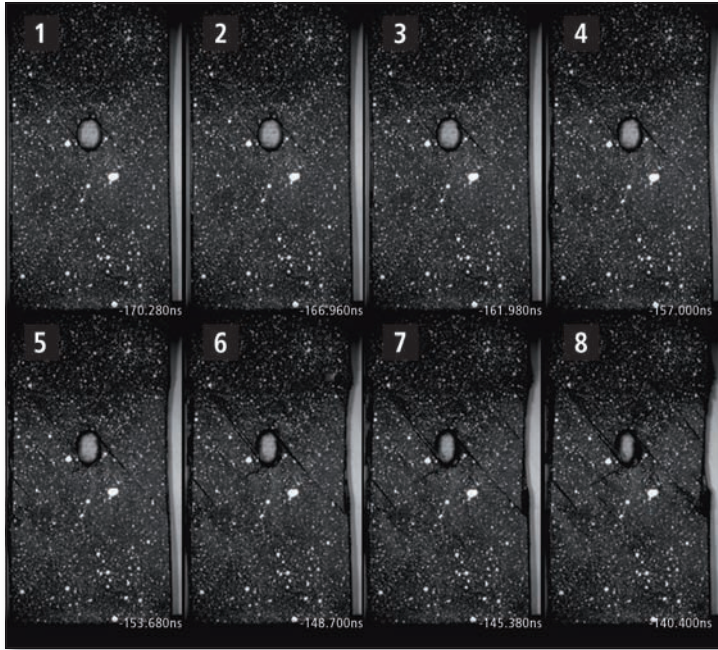
Figure 3: Observation of fracture

Images 1 through 8 in figure 3 capture the behavior of the specimen during fracture around the circular hole. Image 1 shows the moment cracks occur in a surface +45° layer. In this image, the tensile load being applied is deforming the circular hole, with hole diameter in the direction of the load of approximately 1.4 times

that perpendicular to the load. In image 2, cracks around the circular hole are propagating along the surface +45° layer. In images 3 through 6, a substantial change can be observed in the external appearance of the specimen near the end of the crack propagating to the bottom right from the circular hole. This suggests that not only the surface layer, but internal layers are also fracturing. Based on the images of the same area and the state of the internal layers that can be slightly observed from the edges of the circular hole in images 7 and 8, the internal fracture has propagated quickly in the 18 μ s period between images 3 and 8.

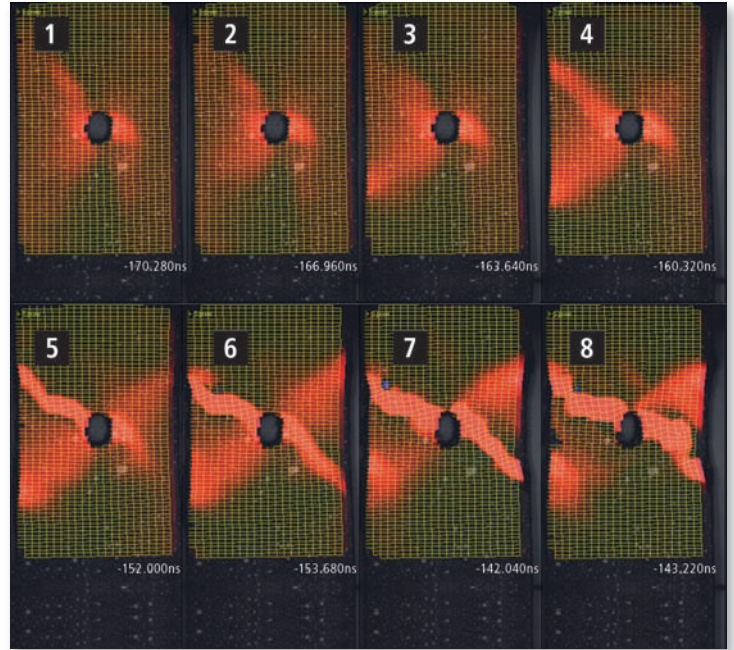
Figure 4: Observation of fracture (DIC analysis)

DIC analysis performed on the fracture observation images of figure 3. Black signifies areas of the surface layer of the specimen under little strain, and red signifies areas under substantial strain. Looking at images 1 through 4 (in figure 4), it can be seen that strain

around the circular hole is focused diagonally toward the top-left (-45°) and toward the bottom-left (+45°) from the circular hole. Images 5 through 8 show the focusing of strain diagonally toward the bottom-right (-45°) and toward the top-right (+45°) from the circular hole in areas where it was not obvious in images 1 through 4. This shows that an event is occurring in the surface layer of the specimen that is similar to the process of fracture often seen during tensile testing of ductile metal materials, i.e. crack propagation in the direction of maximum shear stress.
